INDOOR AIR QUALITY ASSESSMENT

**Hopedale Junior/Senior High School
25 Adin Street
Hopedale, Massachusetts**

Prepared by:
Massachusetts Department of Public Health
Bureau of Environmental Health Assessment
June, 2000

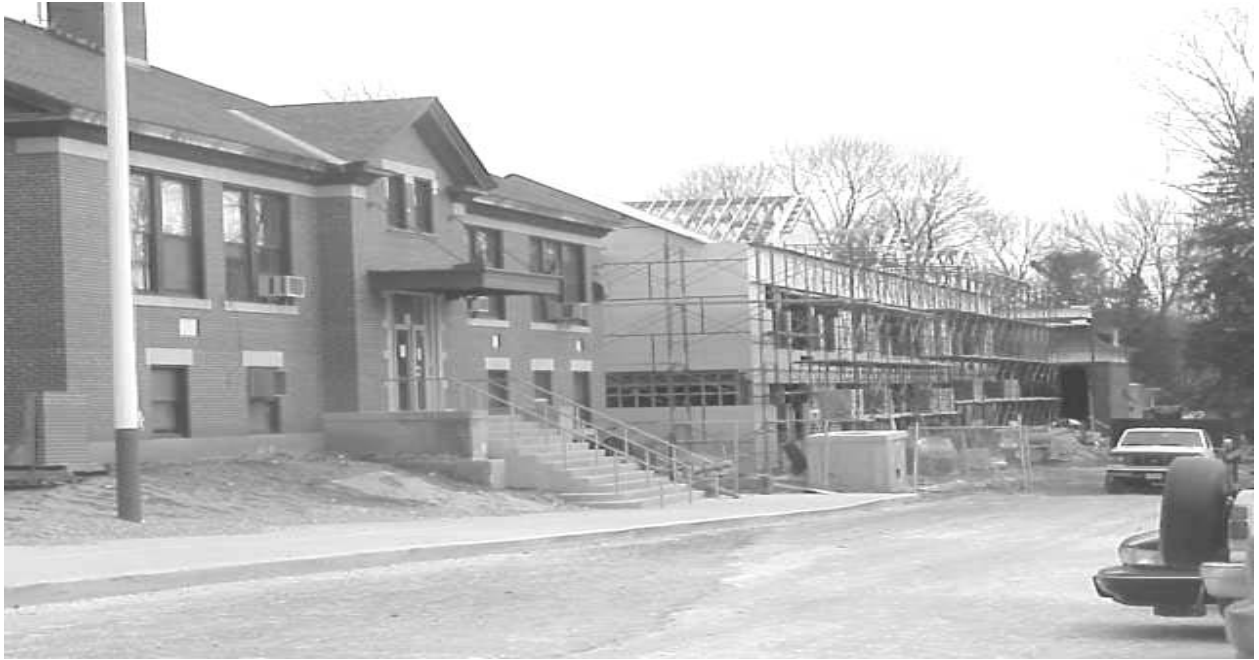
Picture 1

As you know, the school is currently under renovation while occupied by students, teachers and school staff. The planned renovations are to the existing building including an addition of a wing at the south end of the building (see Picture 1). It was reported to BEHA staff that several indoor air quality tests had been conducted previous to this visit. During the assessment, construction activity was limited to work outside the occupied building. No measurable levels of carbon monoxide or unusual odors were detected in the building.

**West Side View of Hopedale Junior/Senior High School
Note Addition Being Built on South Side of Existing Building**
